### WHY IS THERE A NEW FIRMWARE UPDATE PROCESS?

### UPDATING THE FIRMWARE USING THE WEB UI

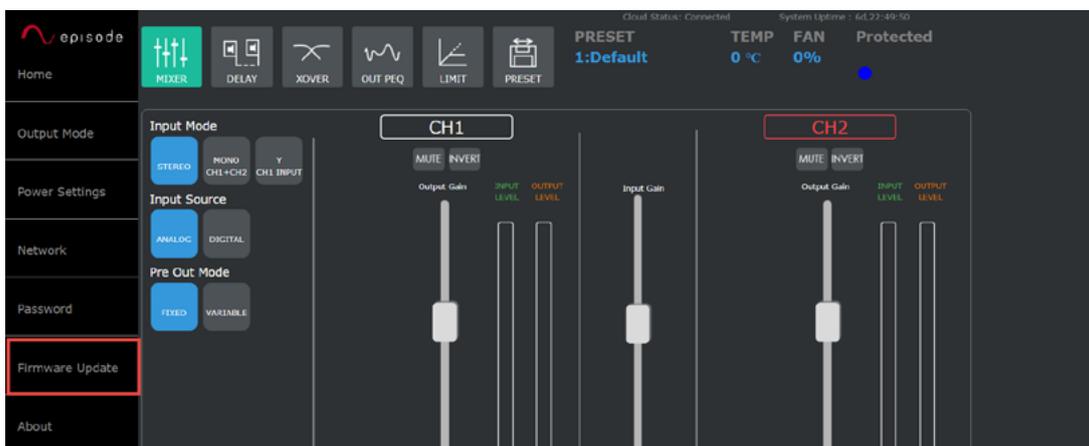
1. Log into the hybrid amplifier and click **Firmware Update**.

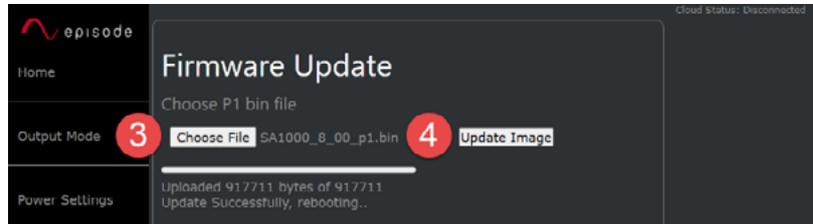
- Click **Choose File**, then locate the correct firmware file for the amplifier being updated.
  - EA-AMP-HYB-2D-2000:** Use the v8.00 file, labeled as **SA1000\_5\_00\_p0.bin** or **SA1000\_5\_00\_p1.bin**. Select the file that matches the file noted in step 2. **P0** or **P1**.
  - EA-AMP-HYB-2D-1000:** Use the v5.00 file, labeled as **SA1000\_8\_00\_p0.bin** or **SA1000\_8\_00\_p1.bin**. Select the file that matches the file noted in step 2. **P0** or **P1**.
- Click **Update Image**. Once the progress bar completes, please wait until a message is displayed underneath the bar showing that the upgrade was successful, which restarts the amplifier.

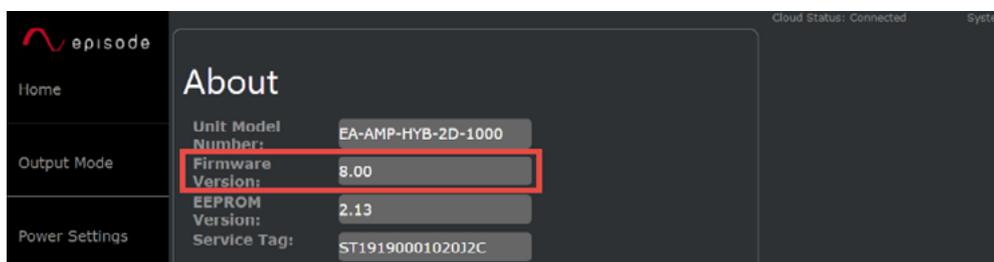
- Refresh the browser to verify the amplifier is back online. Click **About** and verify the hybrid amplifier is on the correct firmware version.  
5.03 for the EA-AMP-HYB-2D-2000. 8.03 for the EA-AMP-HYB-2D-1000.

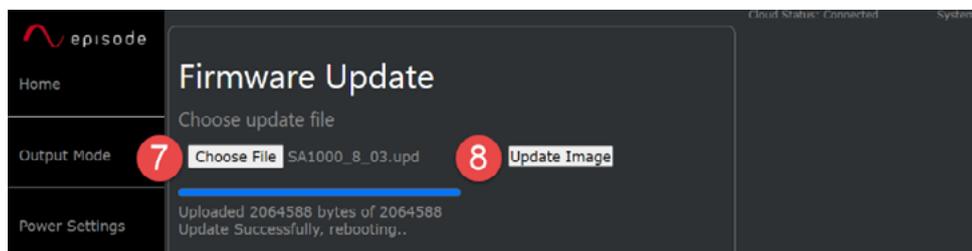
- Click **Firmware Update**, then click **Choose File**.
- Select the second firmware file.
  - EA-AMP-HYB-2D-2000:** Use the **SA2000\_5\_03.upd** file.
  - EA-AMP-HYB-2D-1000:** Use the **SA2000\_8\_03.upd** file.
- Click **Update Image**. Once the progress bar completes, please wait until a message is displayed underneath the bar showing that the upgrade was successful, which restarts the amplifier.

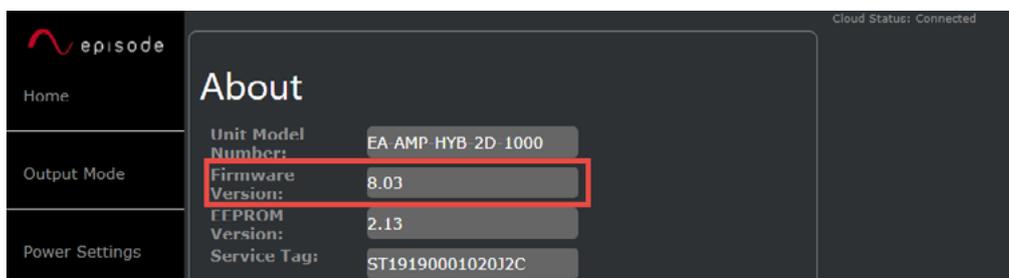
- Refresh the browser to verify the amplifier is back online. Click **About** and verify the hybrid amplifier is on the correct firmware version.  
5.03 for the EA-AMP-HYB-2D-2000. 8.03 for the EA-AMP-HYB-2D-1000.

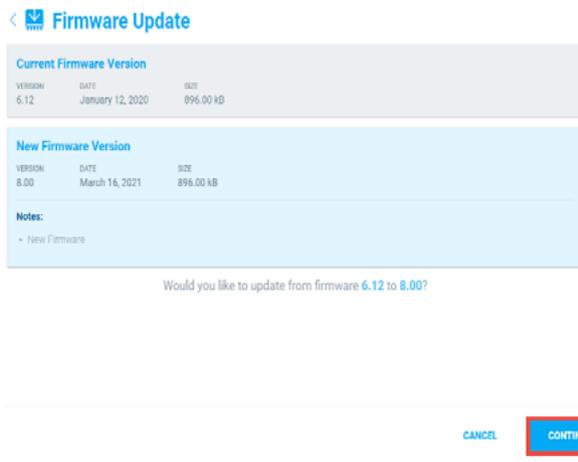
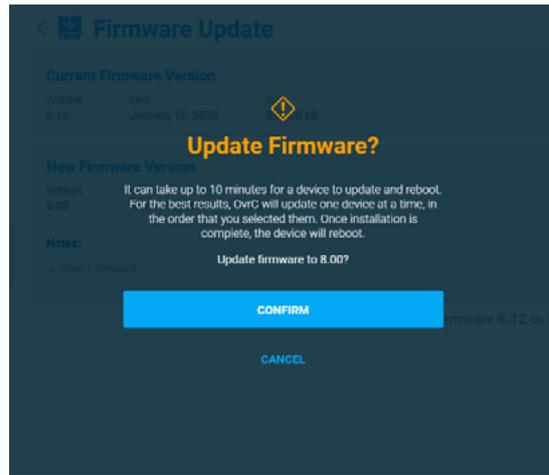
- Click the **Continue** button, then **Confirm** the update.

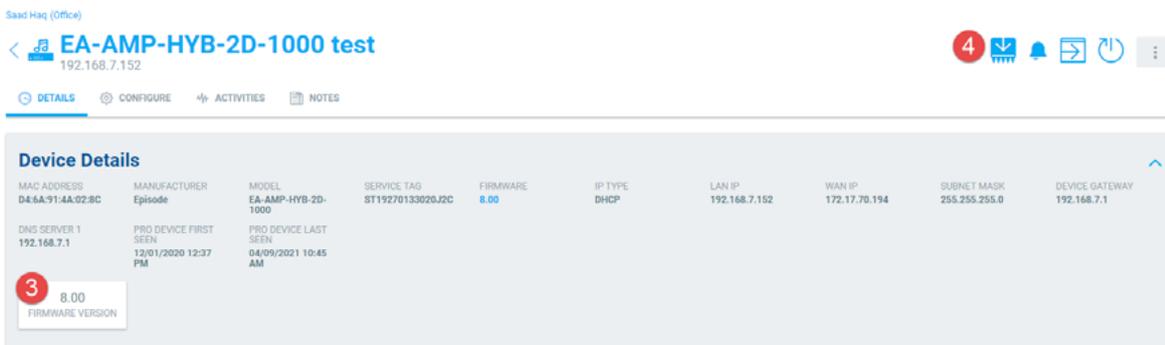
- The update takes a few minutes to complete, during which the hybrid amplifier shows offline in OvrC. Once it is online again, click the device name and confirm the hybrid amplifier is on the updated firmware version. 5.00 for the EA-AMP-HYB-2D-2000. 8.00 for the EA-AMP-HYB-2D-1000.
- Click the **Update** button once more, then **Continue**, and **Confirm**.

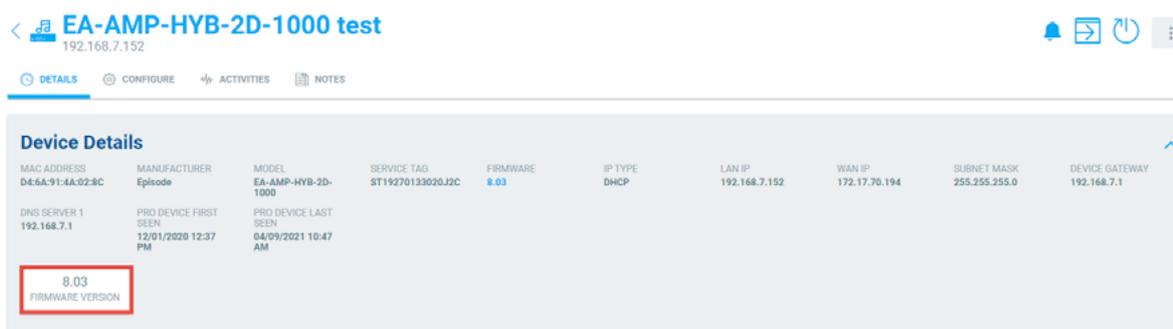
- Once the update completes and the hybrid amplifier is online in OvrC again, click the device name and confirm the firmware version once more. 5.03 for the EA-AMP-HYB-2D-2000. 8.03 for the EA-AMP-HYB-2D-1000.

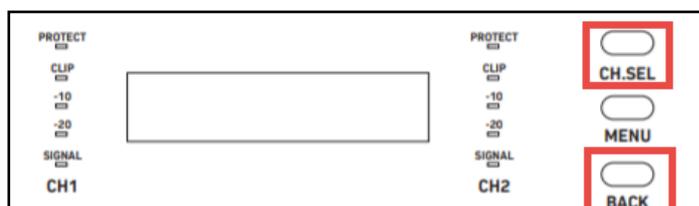
- Turn off the amplifier with the power switch.
- Hold the **CH. SEL** and **BACK** buttons simultaneously, while turning the unit on with the power switch to enter bootloader mode.

3. The **Protect** LED should flash rapidly (both **CH1** and **CH2**).
4. **Signal** LEDs for both **CH1** and **CH2** indicate the partition the unit is on. If both LEDs are illuminated green, the unit is on partition 1 (p1). If both LEDs are not illuminated, the unit is on partition 0 (p0).  
**Note:** *The unit should not be in a state where one Signal LED is illuminated and the other is not. Firmware cannot be loaded in such a state.*
5. To set the desired partition for **CH2** Signal LED, press and hold the **CH.SEL** button until the LED is illuminated or not illuminated.
6. To set the desired partition for **CH1** Signal LED, press and hold the **BACK** button until the LED is illuminated or not illuminated.
7. Power cycle the amplifier and retry the firmware update.
