EA-AMP-HYB-2D-X000 HYBRID AMPLIFIER

WHY IS THERE A NEW FIRMWARE UPDATE PROCESS?

UPDATING THE FIRMWARE USING THE WEB UI

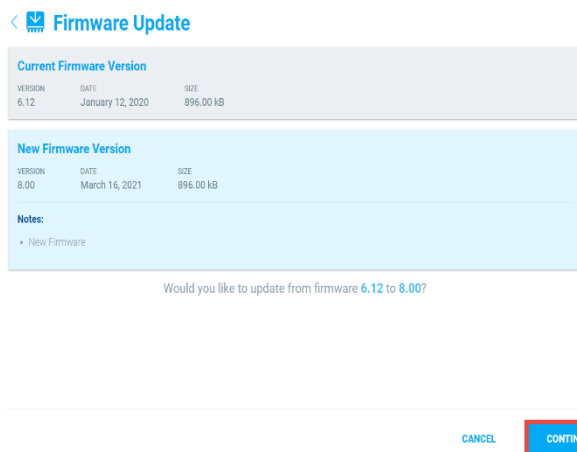
- Click the **Continue** button, then **Confirm** the update.
